2025 RETAINING WALL AND LANDSLIDE REPORT

Department of Transportation and Engineering
Division of Engineering
Structures and Geotechnical Section

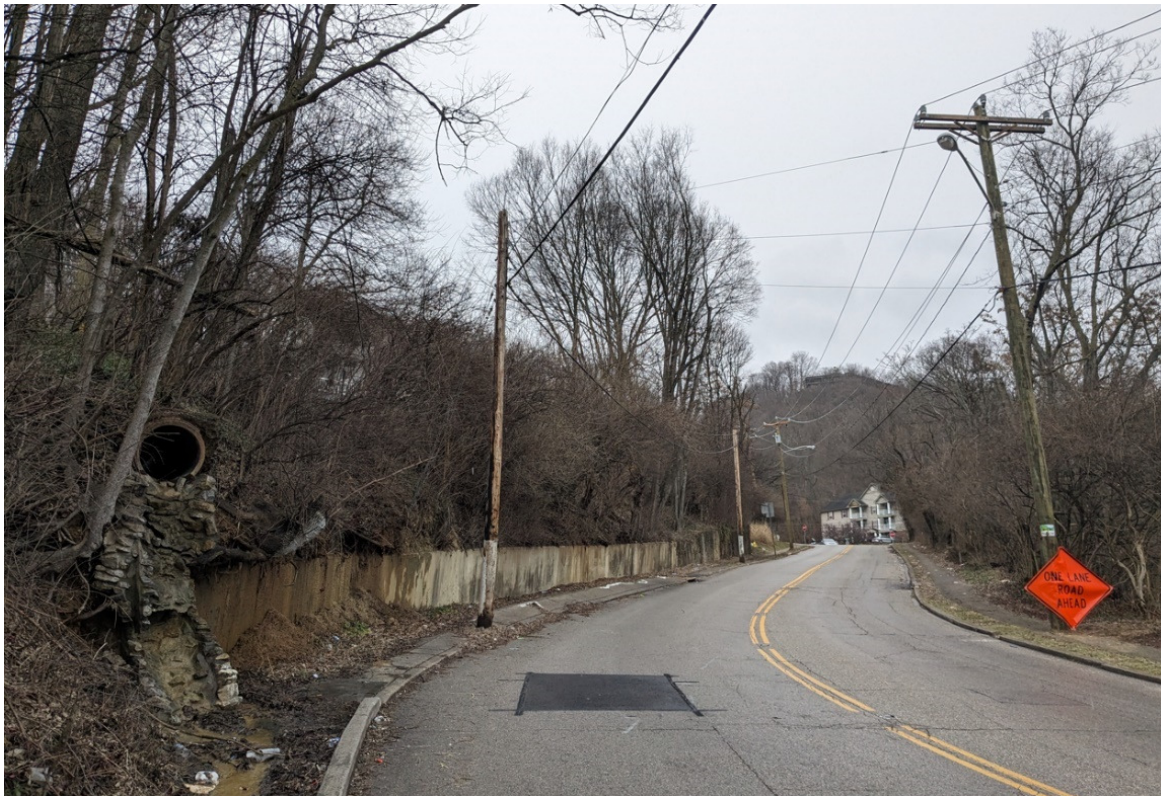
Hillside movement had caused the retaining wall along the west side of Anderson Ferry Road, between Hillside Avenue and River Road to flex and the wall was being overtopped by soil. The sidewalk had buckled and was closed in February of 2020. The project has stabilized the slope with a tied-back soldier pile retaining wall constructed behind the existing wall. The wall was also extended 45 feet south from the existing wall to allow for the walk to be extended, closing a long-standing gap. The new walls allow stormwater infrastructure to properly collect water behind the wall to allow the sidewalk to be repaired and extended to River Road.

Anderson Ferry Road, Before

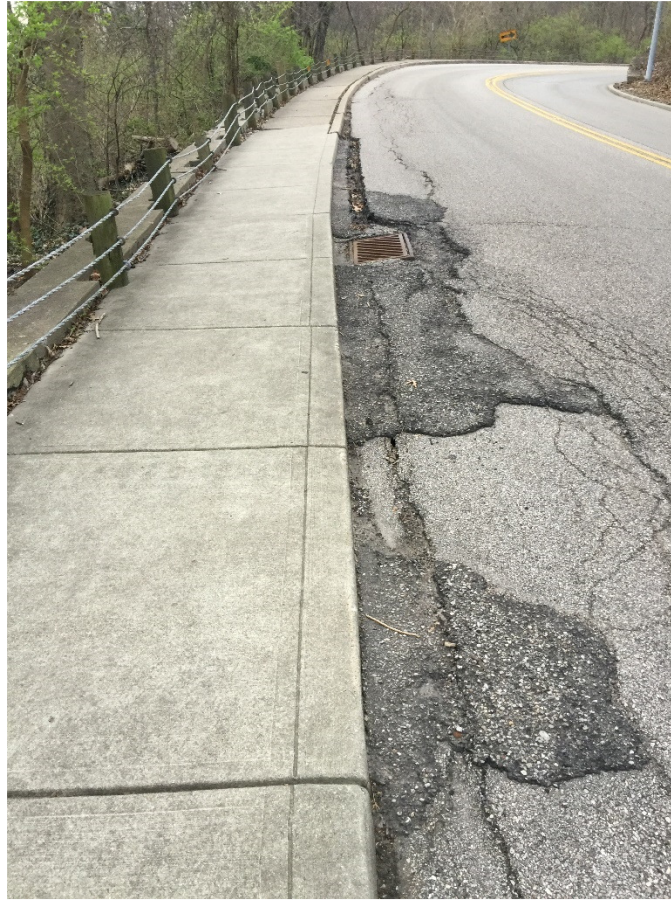
Hillside movement impacted Art Museum Drive for a distance of approximately 662 feet from its intersection with Eden Park Drive. The retaining wall constructed in the 1930's was founded within the overburden soil and was failing, causing separation of the sidewalk from the curb, deterioration of the sidewalk, separation of the curb from the roadway and tension cracks within the pavement.

Art Museum Drive, Before

The stabilization project involved the installation of a drilled pier retaining wall along the downhill side of the existing retaining wall. Thirty-inch diameter piers were installed at eight (8) feet on center. Precast concrete panels and a wall cap were installed between and on top of the piers. The sidewalk was widened and a new vehicle barrier and pedestrian rail were installed on the wall. The existing cable post guardrail on the south side of Eden Park Drive was also replaced with steel-backed timber rail as part of this project.

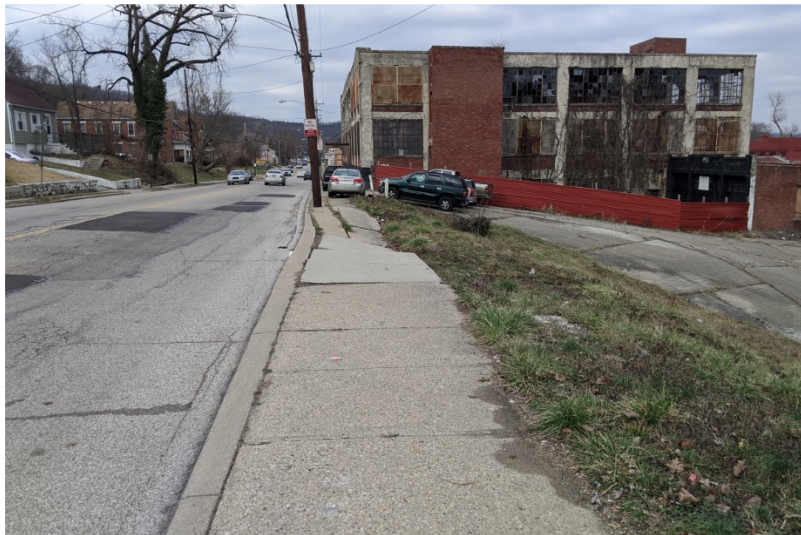
A private retaining wall collapse on the property at 3090 Beekman Street caused a landslide that extended up to the roadway, resulting in the destruction of the sidewalk and the realignment of curb. Pavement was being distressed and there was fear of distress to adjacent utilities. The Department of Community and Economic Development (DCED) had taken control of the property.

Beekman Street, Before

DOTe designed a soldier pile wall comprised of 12 piers with steel piles and pre-cast concrete lagging panels. DOTe was awarded OPWC SCIP funding for a much larger street improvement/pedestrian safety project that included this wall as it was needed to repair the sidewalk, curb and pavement in this area. The overall project funding sources, in conjunction with the SCIP grant, were able to cover the cost for the wall/landslide repair. The Wall Stabilization and Landslide Correction Program funded the investigation and in-house design (\$17,714).

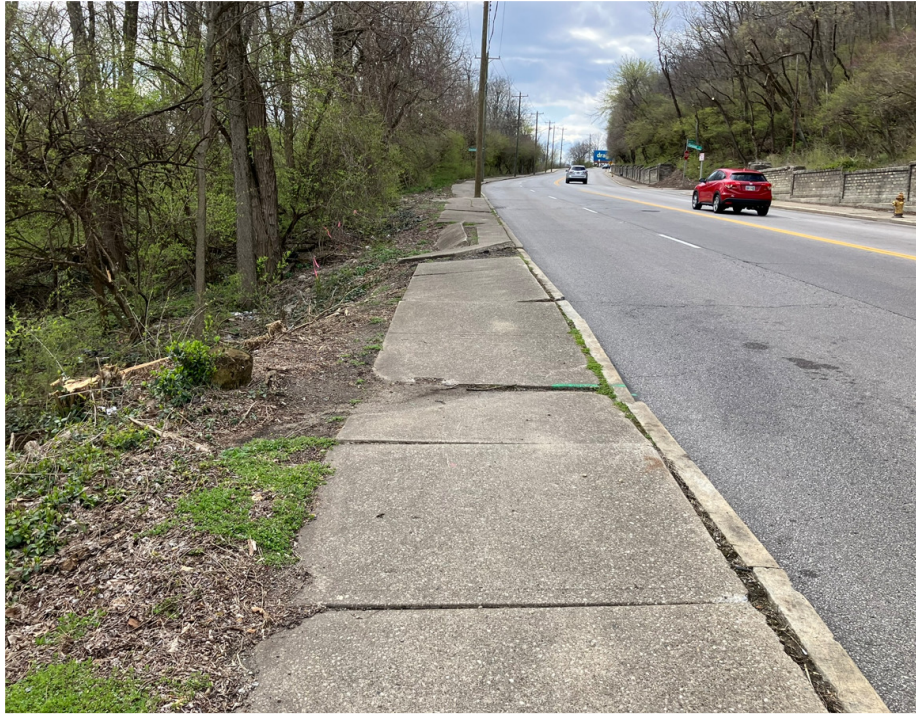
Private properties that were filled for apartment developments in the early to mid-1900's created an instability along the south side of Harrison Avenue, east of Everglade Place. The apartments were razed in the 1960's due to landslide damage. The landslides span east and west from a single remaining apartment complex at 1765 Harrison Avenue. Slope movement has resulted in the destruction of the sidewalk and the realignment of curb. Pavement was being distressed and there was fear of distress to adjacent utilities. A safety improvement project was planned in the area, requiring the sidewalk to be repaired and reopened. Two (2) drilled piers and plug walls 195 feet and 176 feet in length were designed in-house and constructed as part of the safety improvement project. The wall allows for reconstruction of the curb and walk.

Harrison Avenue, Before

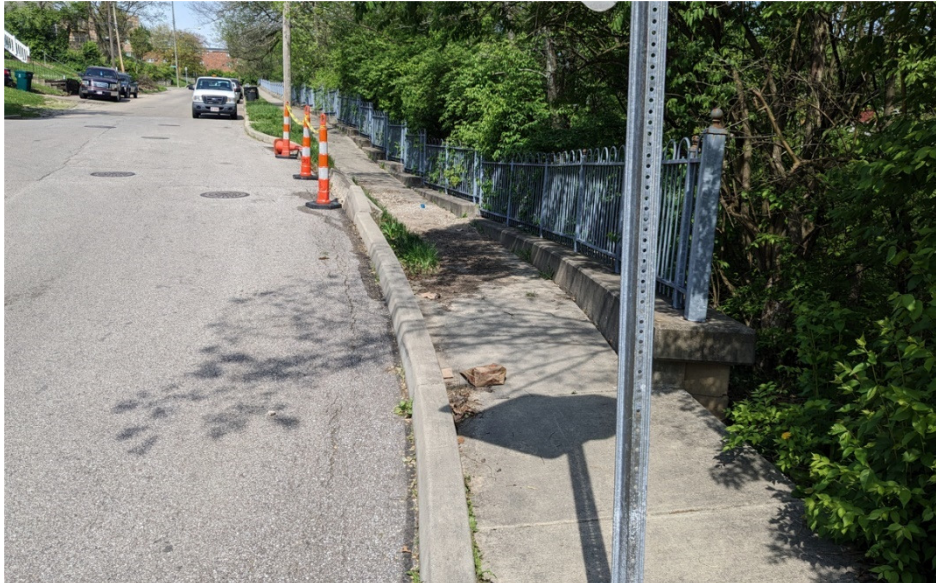
A section of modular retaining wall constructed in 2000 settled and translated (slid) downslope. This resulted in sidewalk settlement and loss of curb across from Summit Avenue.

Maryland Avenue Wall Reconstruction – Before

DOTe Contracted for the removal and reconstruction of the eastern 114 feet of the wall, including the additional wall depth, new wall cap, reuse of railing, and replacement of walk and curb.

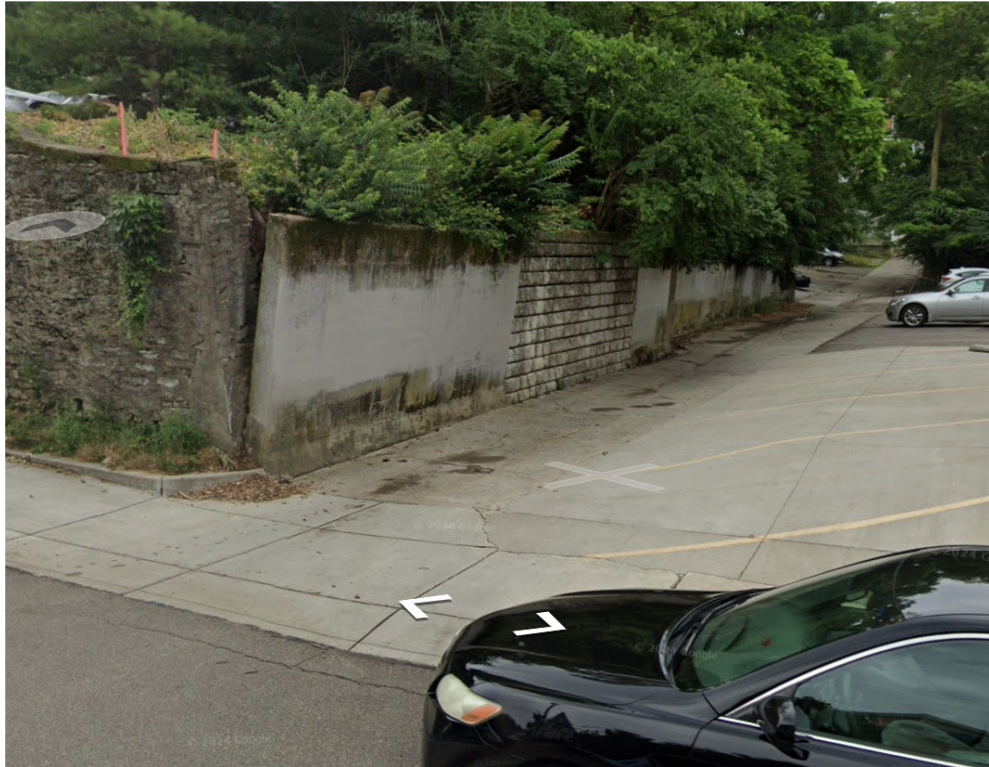
A 20-foot-long section of cantilevered concrete retaining wall from 1929 at the north end of the alley was at risk of collapse. A similar section to the south of this area was replaced with modular retaining wall units in 2007.

Eucledan Alley Wall Reconstruction – Before

DOTe contracted for the removal and reconstruction of the northern 20 feet of this wall. During construction, it was noted that the 2007 repair was constructed with a batter (lean)

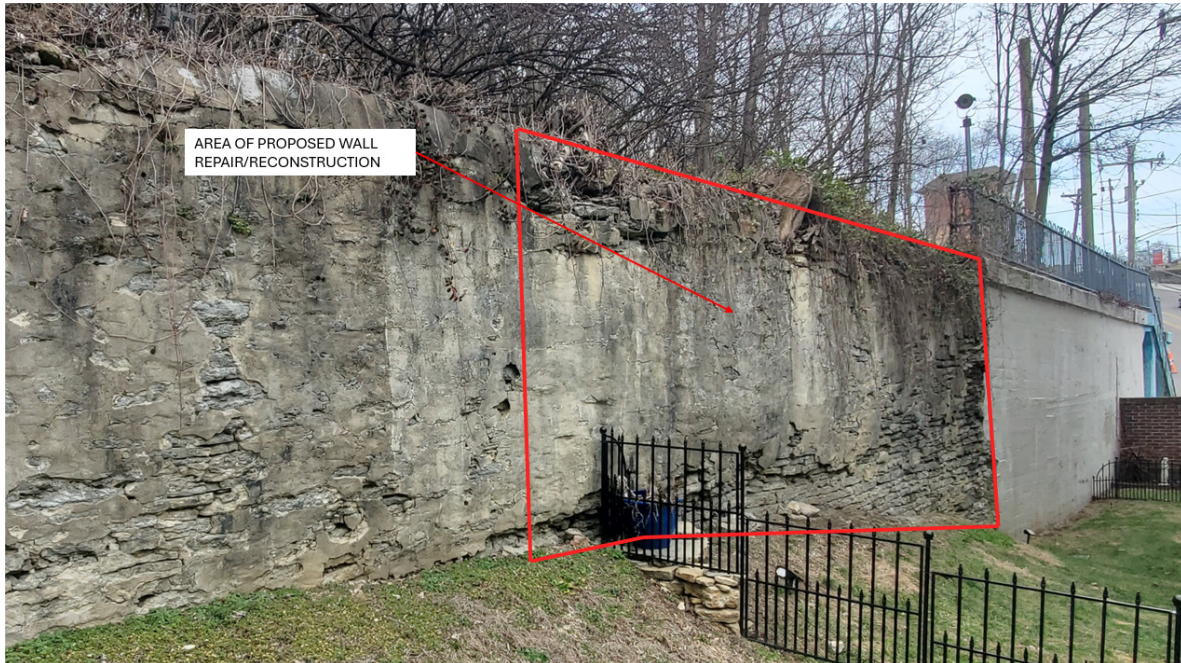
A 40-foot long section of a stone gravity wall located along the north side-yard of the property at 1809 Sycamore Street and presumed to date from the late 1800's/early 1900's was at risk of collapse. The risk of failure could have impacted the adjacent house.

Sycamore Street Wall Reconstruction – Before

DOT E contracted for the removal and reconstruction of 40 feet of this wall by restacking a similar gravity, mortared stone wall.

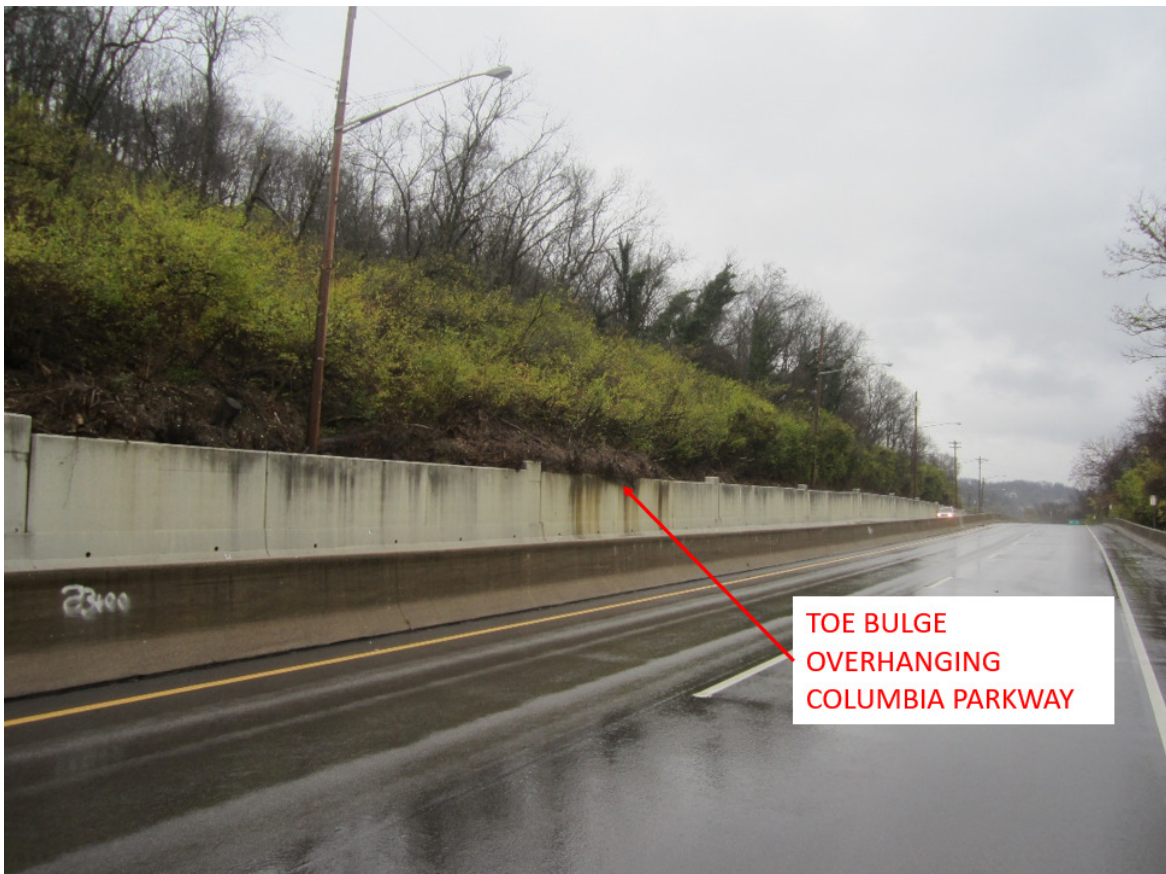
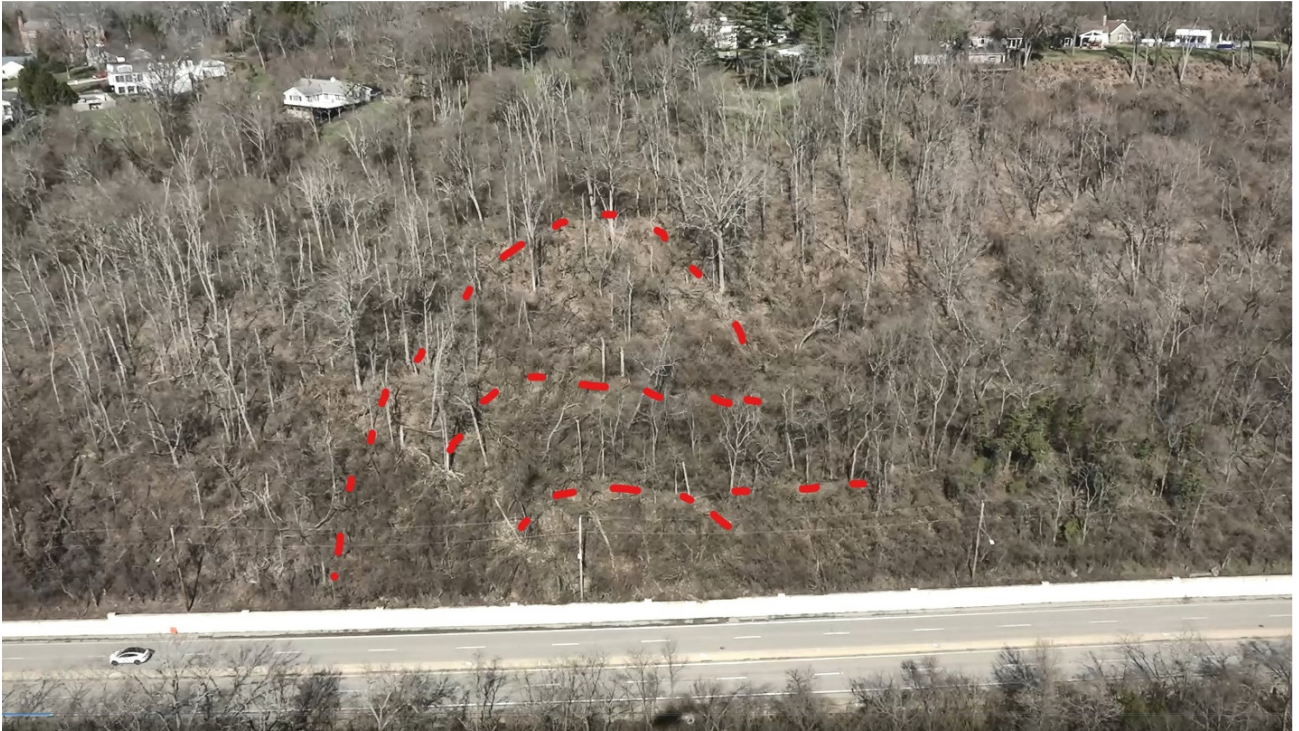
Public Services trimmed the vegetation along Columbia Parkway in the summer of 2020. The removal of the vegetation exposed the toe of a landslide on the hillside above the retaining wall between Beechmont Avenue and the curve in the parkway below Alms Park. Comparison of photographs of the area suggests that the slide occurred sometime after June of 2018.

Columbia Parkway Landslide, South of Beechmont

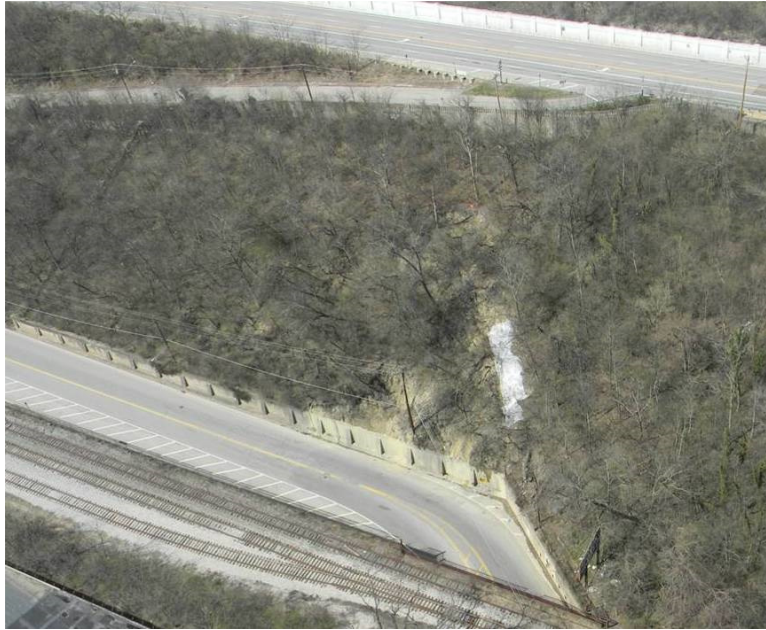
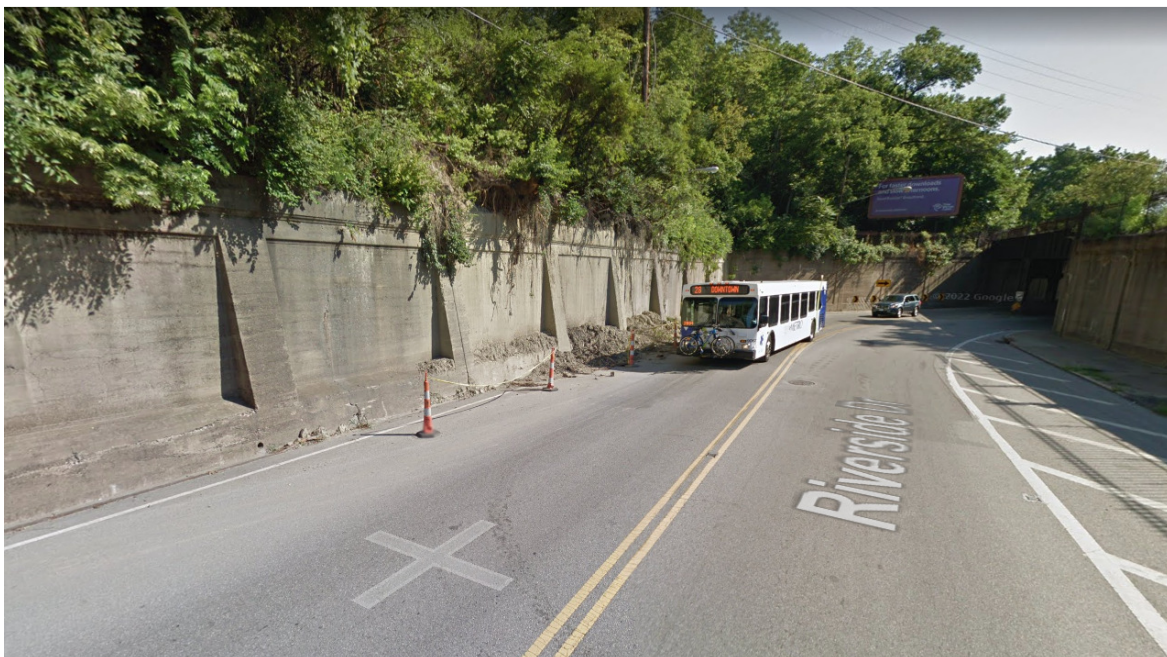
(The property above the wall is owned by the Park Board. Note extent of head scarp. Plastic sheet left behind after test pits were dug in 2011 to prevent water from seeping along scarp line into the slide mass. Plastic has since deteriorated and no longer exists.)

Significant movement has not occurred since the spring seasonal rains of 2011 however the bike lane regularly has rocks and mud in it due to the slow advancement of the landslide. Removal of the toe cannot take place until the slide mass is stabilized. The threat of rapid movement will exist until the slide mass is stabilized. The pavement in the area often remains wet during the winter due to seepage out of the landslide bulges that rest on top of the wall. This water freezes before reaching inlets and causes hazardous icing conditions.

Riverside Drive at Rookwood Overpass Landslide

The stabilization project is intended to be let as design/build to allow contractors to utilize their most efficient construction concepts to achieve the goal of keeping debris out of the roadway. The work is anticipated to include the construction of a soldier pile or soil nail stabilization system located approximately 20 feet behind the top of the existing wall for a length of 180 feet. The 20-foot setback will serve as a catchment zone if the stabilization system is over-topped.

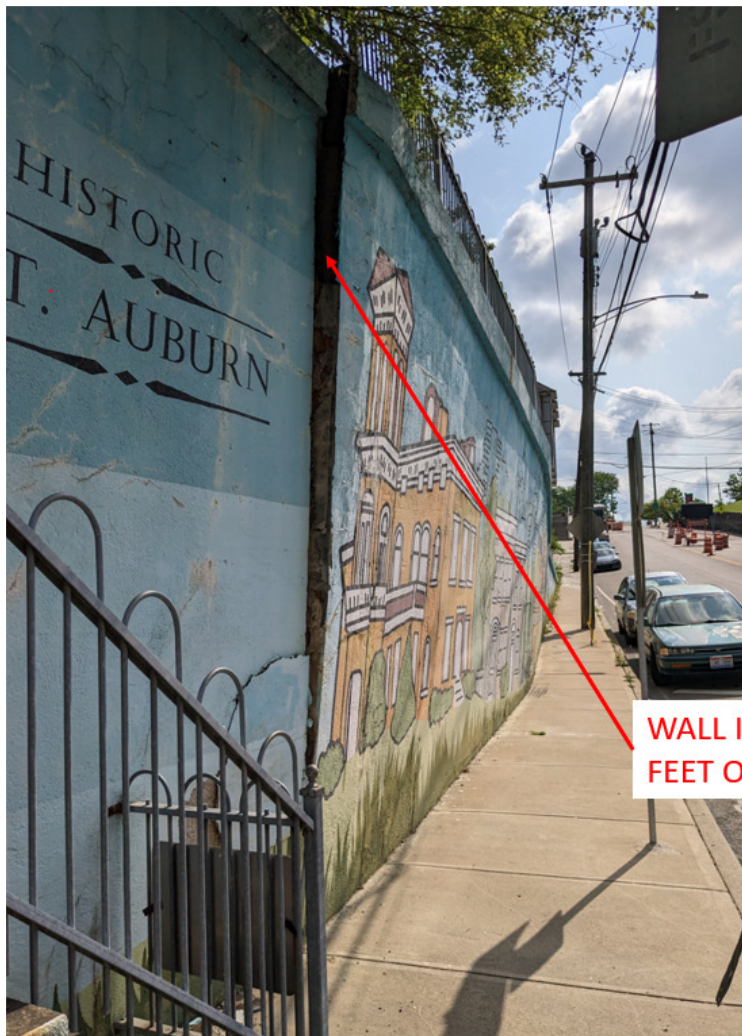
WALL IS NEARLY 2
FEET OUT OF PLUMB

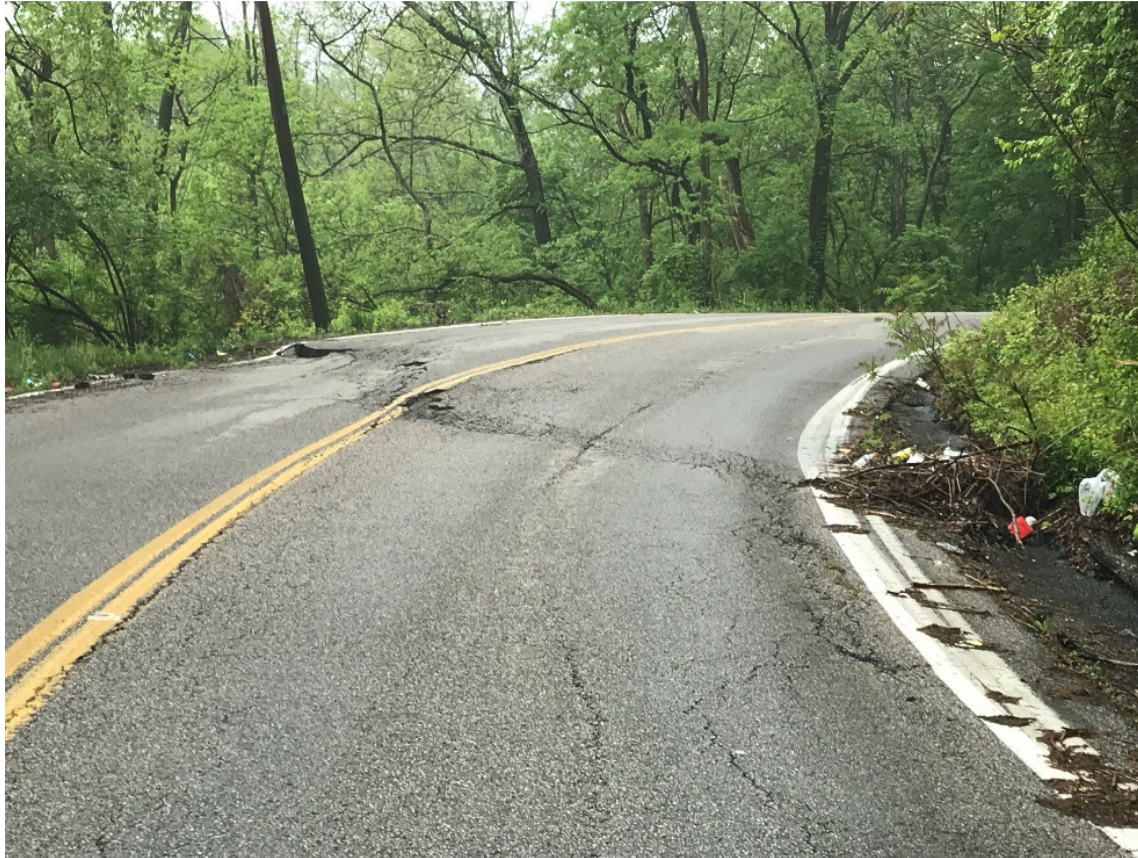
Faraday Road - Scarp (set down) in Pavement (has since been patched)

The repair will consist of piping and filling 800 feet of the ravine along the east side of the road and will include an improved outfall to the West Fork Channel as well as a paved gutter on the west (upslope) side of Faraday Road to intercept surface water. The design is being completed by a consultant contracted through DOTE.

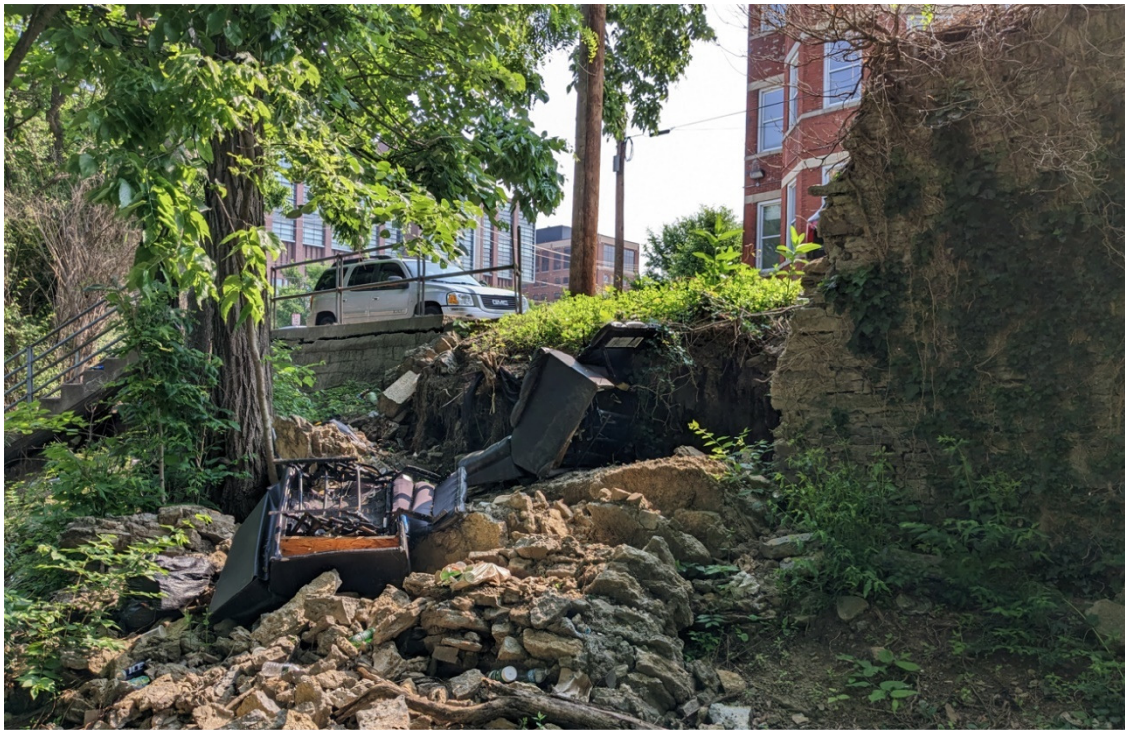
Eleanor Place - Collapsed Wall Section

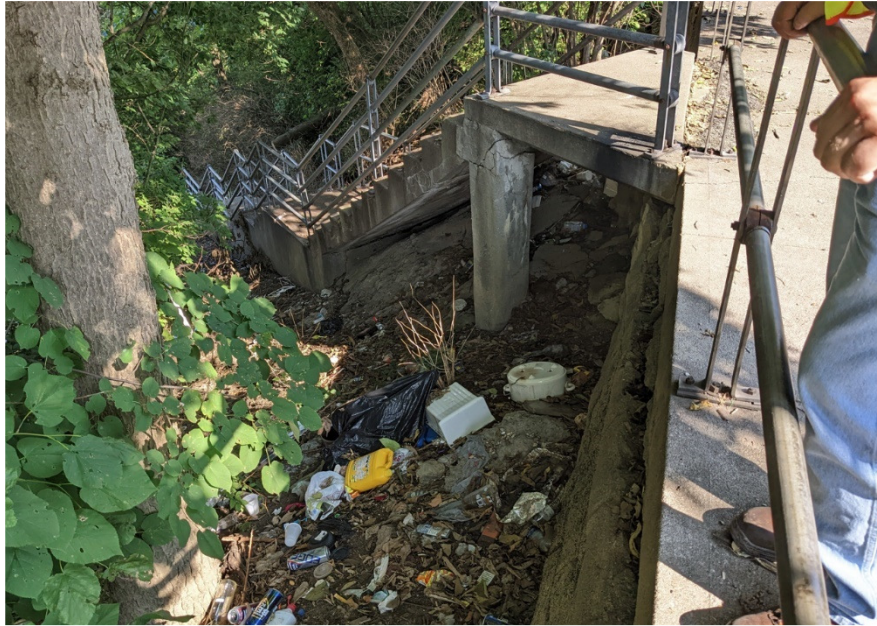
Eleanor Place - Upper Flight of Stairs (pushed by wall deflection)
