# Pavement Evaluation Report

## City of Cincinnati, OH

March 2026

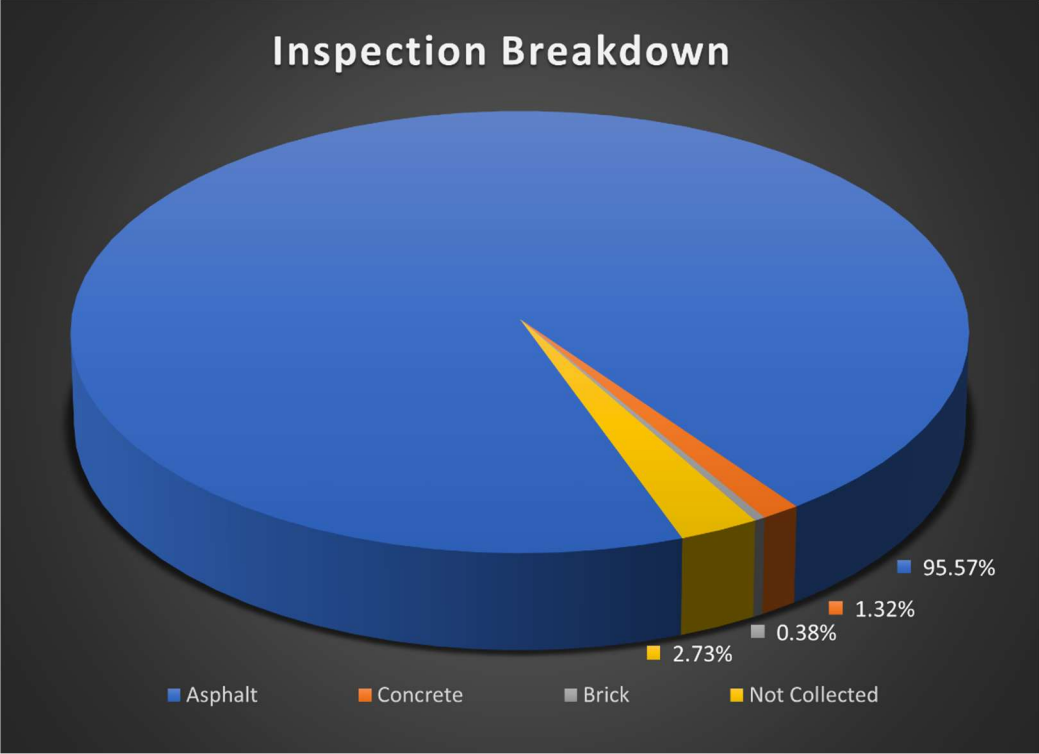
Figure 3.2: City of Cincinnati, OH Inspection Breakdown

<b>Item</b>	<b>Description</b>	<b>Centerline Miles</b>	<b>Percent of Centerline Miles</b>
<b>1</b>	Asphalt Segments with PCI	967.23	95.57%
<b>2</b>	Concrete Segments with PCI	13.40	1.32%
<b>3</b>	Brick Segments with PCI	3.80	0.38%
<b>4</b>	Not Collected – Not Accessible	17.95	1.77%
<b>5</b>	Not Collected – Gated	3.65	0.36%
<b>6</b>	Not Collected – Construction	1.48	0.15%
<b>7</b>	Not Collected – Does Not Exist	0.95	0.09%
<b>8</b>	Not Collected – Short Segment	0.94	0.09%
<b>9</b>	Not Collected – GIS Error	0.69	0.07%
<b>10</b>	Not Collected – Private	0.21	0.02%
<b>11</b>	Not Collected – Other	0.19	0.02%
<b>12</b>	Not Collected – Bridge	0.19	0.02%
<b>13</b>	Not Collected – Train Tracks	0.11	0.01%
	<b>Total With PCI</b>	984.43	97.27%
	<b>Total Without PCI</b>	27.64	2.73%
	<b>Total</b>	<b>1,012.07</b>	<b>100.00%</b>

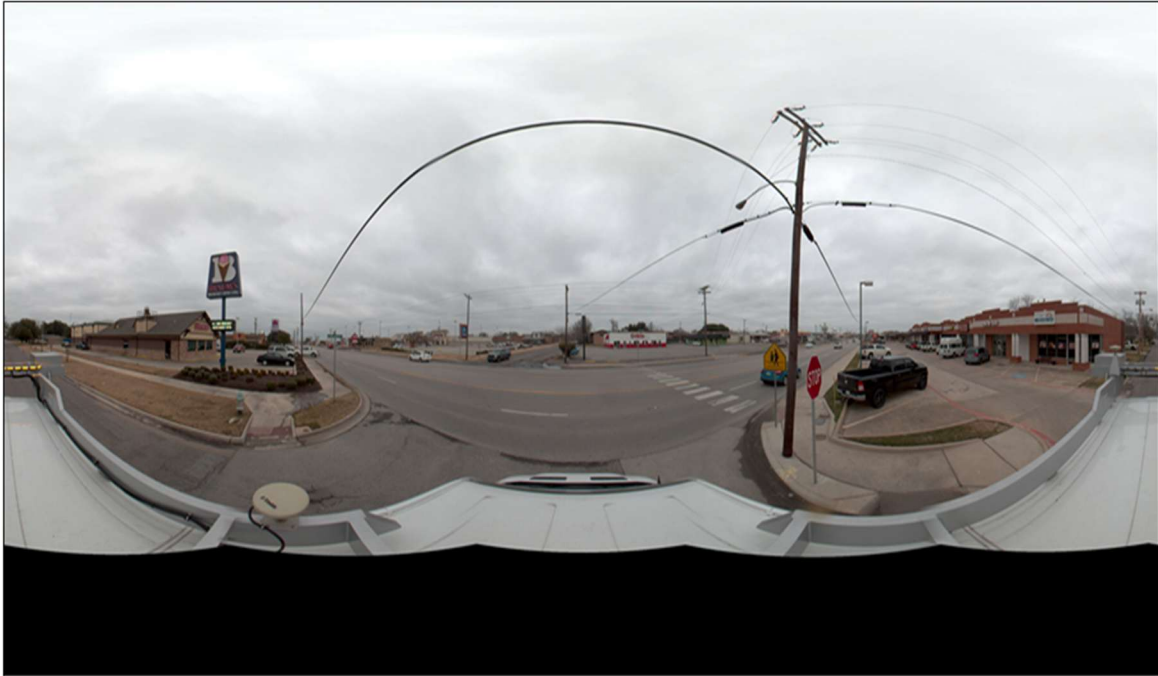
Figure 4.2: Right-of-Way Image Example

The RAC vehicle is configured with a Point Gray Ladybug 5+ 32MP 360-degree camera to provide a full panoramic image of the ROW, displayed in Figure 4.2. The images were captured at roughly 20-foot intervals and were post-processed using collected inertial and GPS data. This allows for more accurate asset extraction to be completed.

The measuring of pavement width can be accomplished utilizing the calibrated Ladybug imagery in conjunction with the LCMS-2 imagery and inertial GPS data. Using the 360-degree view of the ladybug, RAS can accurately and repeatably measure from edge of pavement to edge of pavement for each road segment. This provides a more accurate area calculation for better budgeting and forecasting. For cul-de-sac sections an average width measurement is taken for the straight portion and the bulb. RAS can also calculate the areas of each segment independently and get a true area of the cul-de-sac section. This is one of the topics that are discussed at the working session prior to data collection. The length of a road segment is determined from the GIS database provided by the City. RAS understands that the GIS is not always 100% accurate. In these cases, after collection is complete, RAS can use the GPS trajectory of the van to determine the true beginning and ending of the road to get a more accurate length and therefore a more accurate area measurement.

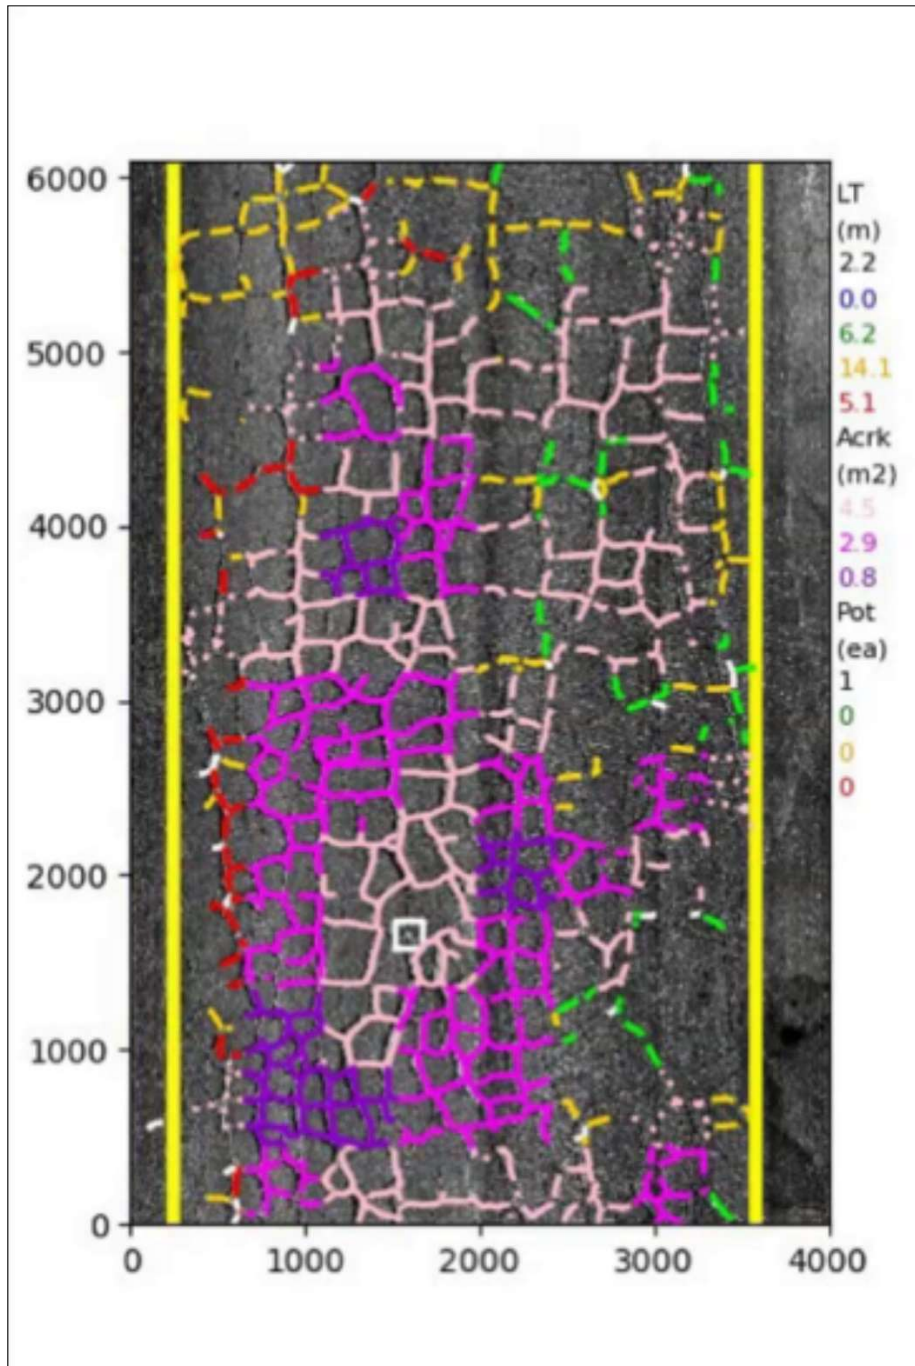
Figure 5.3: Example of Distress Overlay Images

Road TRIP™ uses the depth map created by the Laser Crack Measurement System (LCMS) to locate the valleys and fissures within the surface of the roadway. These valleys and fissures are then measured and rated. Figures 5.2 and 5.3 display an example of distress overlay images.

The LCMS has been set up to follow the ASTM D6433 to determine the severity of each distress. Each distress is defined by ASTM D6433, and the severity levels are presented as measurable attributes of the distress. For example, longitudinal and transverse cracks are defined by the crack width; where non-filled cracks with a width less than 3/8 inch or filled cracks of any width are considered low severity. Moderate severity is defined as non-filled cracks with a width between 3/8 inch and 3 inches. High severity is defined as cracks greater than 3 inches in width or those surrounded by moderate to high severity cracks. The overlay images provide a visual means by which to review the sensor.

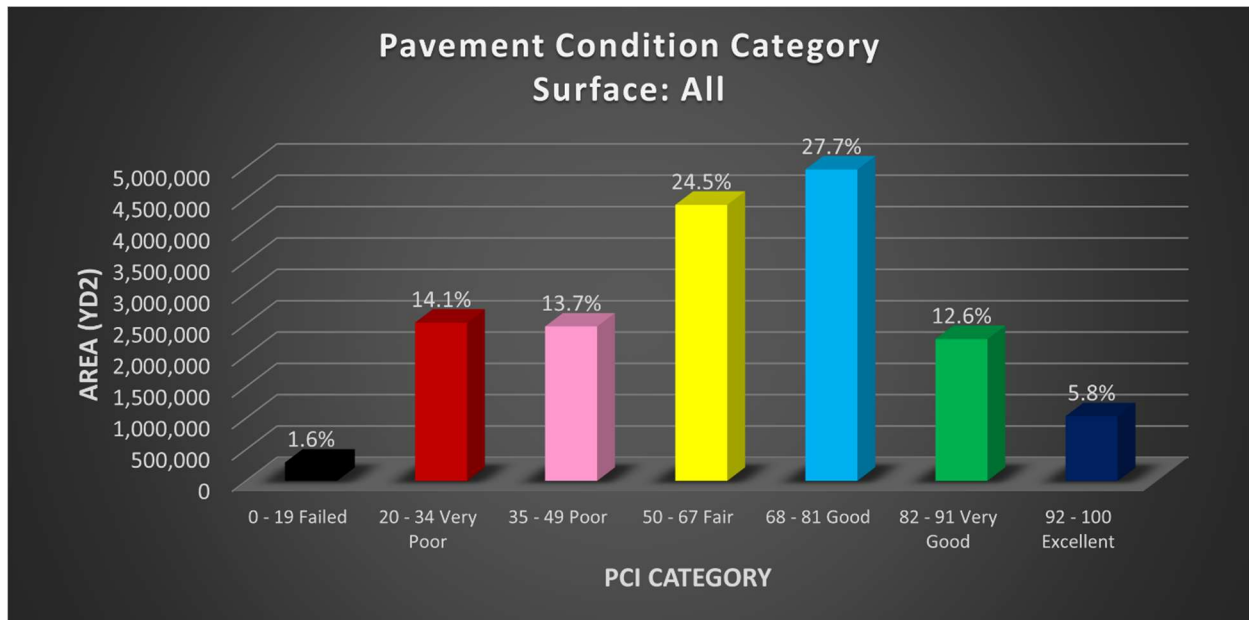
Figure 6.2: City of Cincinnati, OH PCI Ranges by Total Area

The overall pavement network health of the City of Cincinnati can be evaluated by examining Figure 6.2 in more detail. This figure illustrates the percentage of the network area that falls within each descriptive condition category. Key observations from this pavement survey include:

- **Shape of Distribution** – the graph illustrates a distribution that is relatively bell-curve shaped and peaks between a PCI of 68 to 81.
- **Average PCI** – The City’s network average PCI score is 61 (as of September, 2025) and is near the averages that are typically seen across the country between a 60 to 65.
- **Good Roads** – Currently 18.4% of the City’s roadways fall into the Very Good and Excellent PCI condition categories, which is above the national average of 15%.
- **Backlog** – these are the roads that fall below a PCI of 40 and land in the Very Poor, Serious, and Failed condition categories. Currently approximately 21.6% of the roadway network falls into this category, which is considered high compared to the national average.

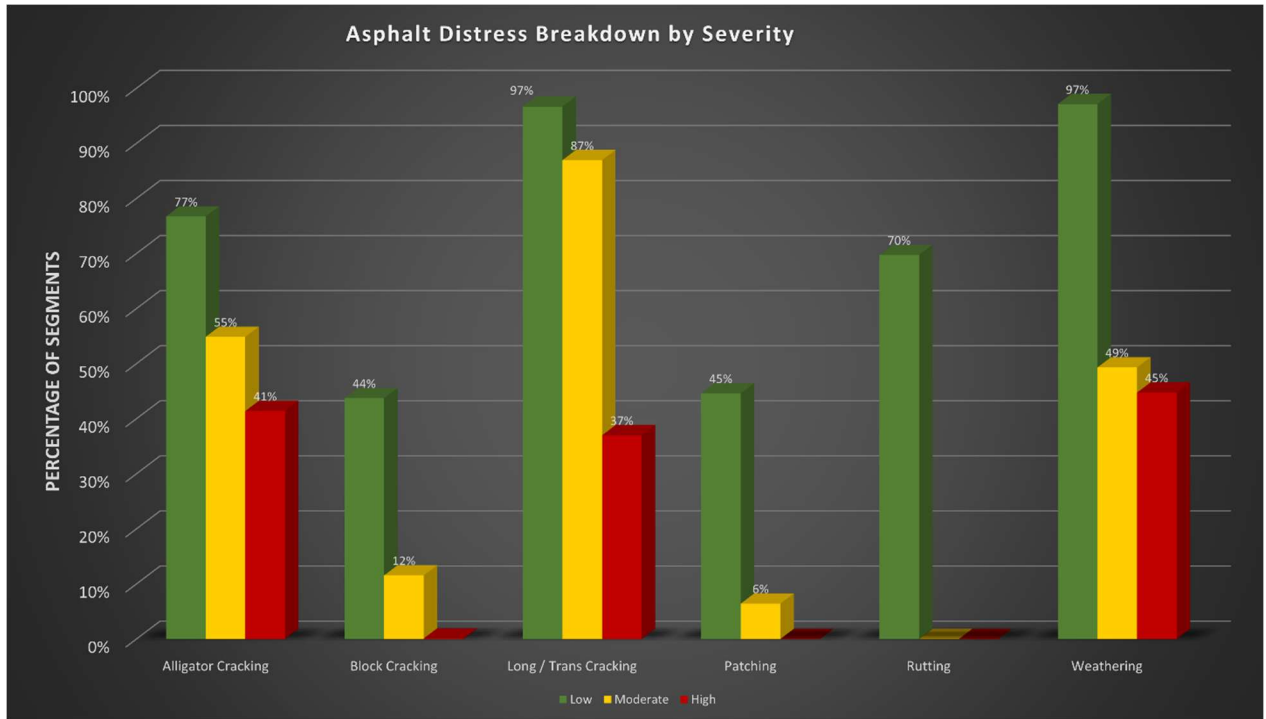
Figure 6.12: Cincinnati, OH Asphalt Distress Breakdown by Percentage of Segments

Figures 6.12 and Tables 6.7 and 6.8 display the types of distresses identified in Cincinnati's asphalt streets. The figures and tables titled "*...Breakdown by Percentage of Segments*" show the percentage of segments that contain each distress type and severity level. Each distress is considered independently, meaning the percentages reflect the presence of a distress within a segment—not the area it covers. For example, if 76% low alligator cracking is reported, it indicates that 76% of the total street segments exhibit some amount of low-severity alligator cracking. Similarly, 41% high alligator cracking means that 41% of all segments contain at least some high-severity alligator cracking.

Asphalt Distress Breakdown by Percentage of Segments			
Type	Low	Moderate	High
Alligator Cracking	76.75%	54.88%	41.41%
Block Cracking	43.75%	11.56%	0.12%
Long / Trans Cracking	96.69%	86.96%	37.00%
Patching	44.62%	6.44%	0.00%
Potholes	0.05%	0.01%	0.00%
Rutting	69.75%	0.00%	0.00%
Weathering	97.14%	49.33%	44.77%

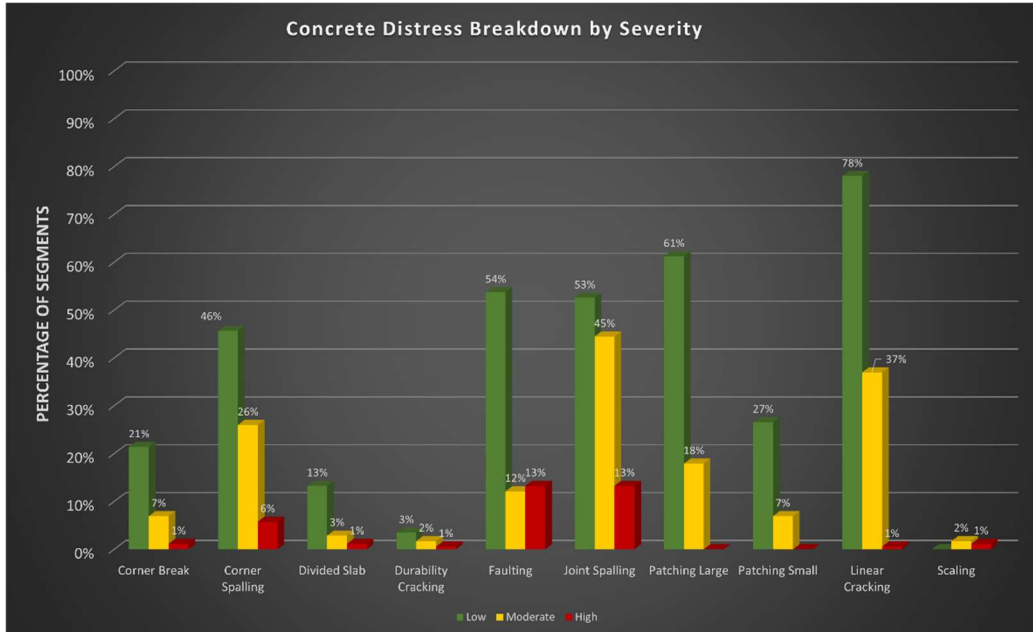
Figure 6.13: Cincinnati, OH Concrete Distress Breakdown by Percentage of Segments

The following charts and figures follow the same logic as the asphalt distresses but show concrete distresses. It is important to note that concrete distresses are measured based on their presence in a slab and thus is not possible to determine the average density of a distress on a road, rather only the presence of that distress.

Concrete Distress Amounts by Percentage of Segments			
Type	Low	Moderate	High
Corner Break	21.39%	6.94%	1.16%
Corner Spalling	45.66%	26.01%	5.78%
Divided Slab	13.29%	2.89%	1.16%
Durability Cracking	3.47%	1.73%	0.58%
Faulting	53.76%	12.14%	13.29%
Joint Spalling	52.60%	44.51%	13.29%
Patching Large	61.27%	17.92%	0.00%
Patching Small	26.59%	6.94%	0.00%
Linear Cracking	78.03%	36.99%	0.58%
Scaling	0.00%	1.73%	1.16%

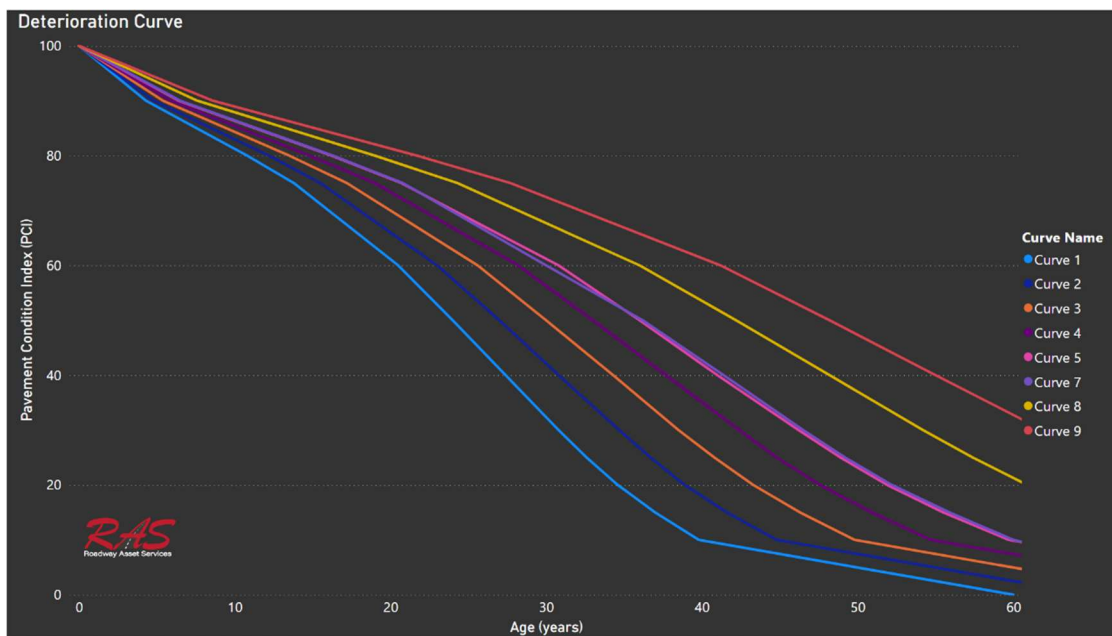
Figure 9.1: City of Cincinnati, OH Deterioration Curves with No Maintenance

Deterioration curves were established for each roadway classification (major, intermediate, and local) and follow similar degradation standards as outlined by ASTM D6433 and the US Army Corps of Engineers. In future pavement condition assessments, it is suggested that the consultant conduct a thorough comparison of the current inspection data against the previous condition assessment. Such an analysis will allow for further refinement of the pavement deterioration curves to ensure they reflect reasonable rates of degradation in Cincinnati, OH. Such an analysis should be conducted after every pavement condition update. The pavement deterioration curves were assembled to establish a 100 - 0 deterioration curve for each functional classification as demonstrated in Figure 9.1 below.

These curves represent the deterioration of roads of all surface types and all classifications without maintenance.

Reviewing deterioration rates for unmaintained roads as part of each condition data collection cycle and adjusting deterioration curves is a recommended best practice.

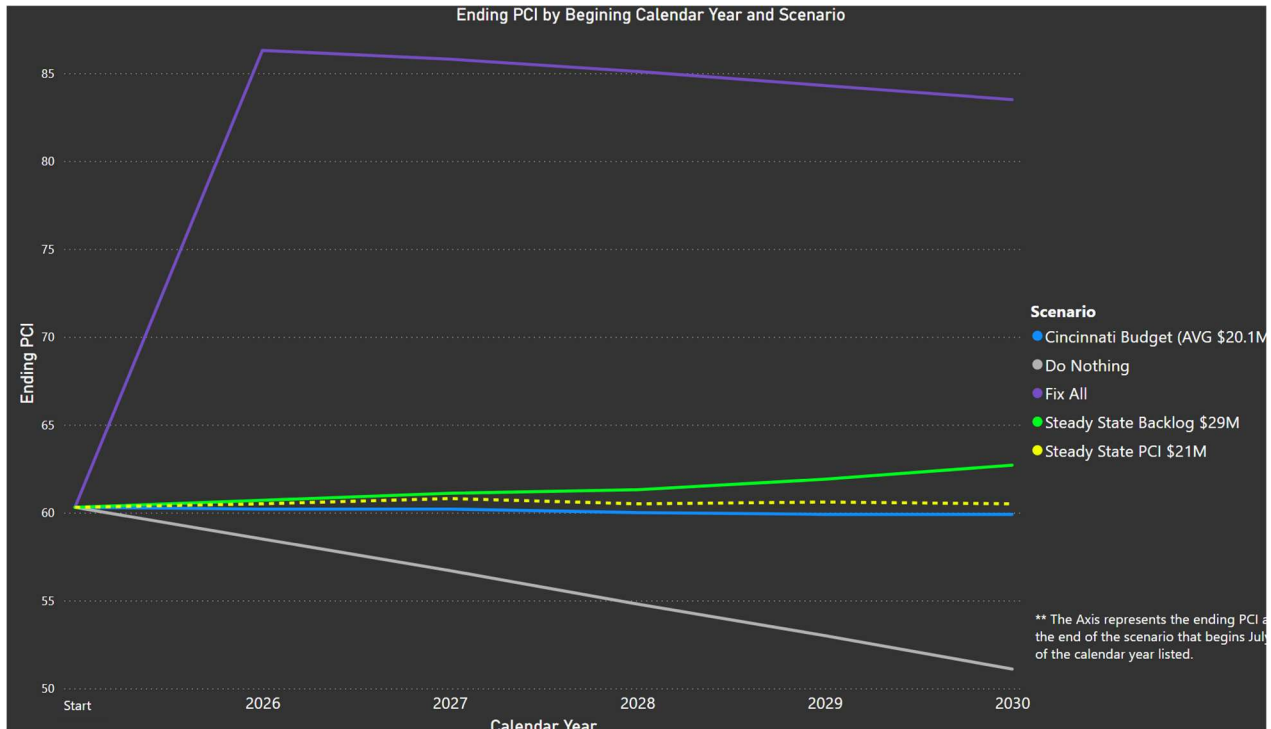
Figure 9.2: City of Cincinnati, OH- PCI Trend by Budget Scenario

Approximately \$21,000,000 per year is needed to maintain a Network PCI of ~60.

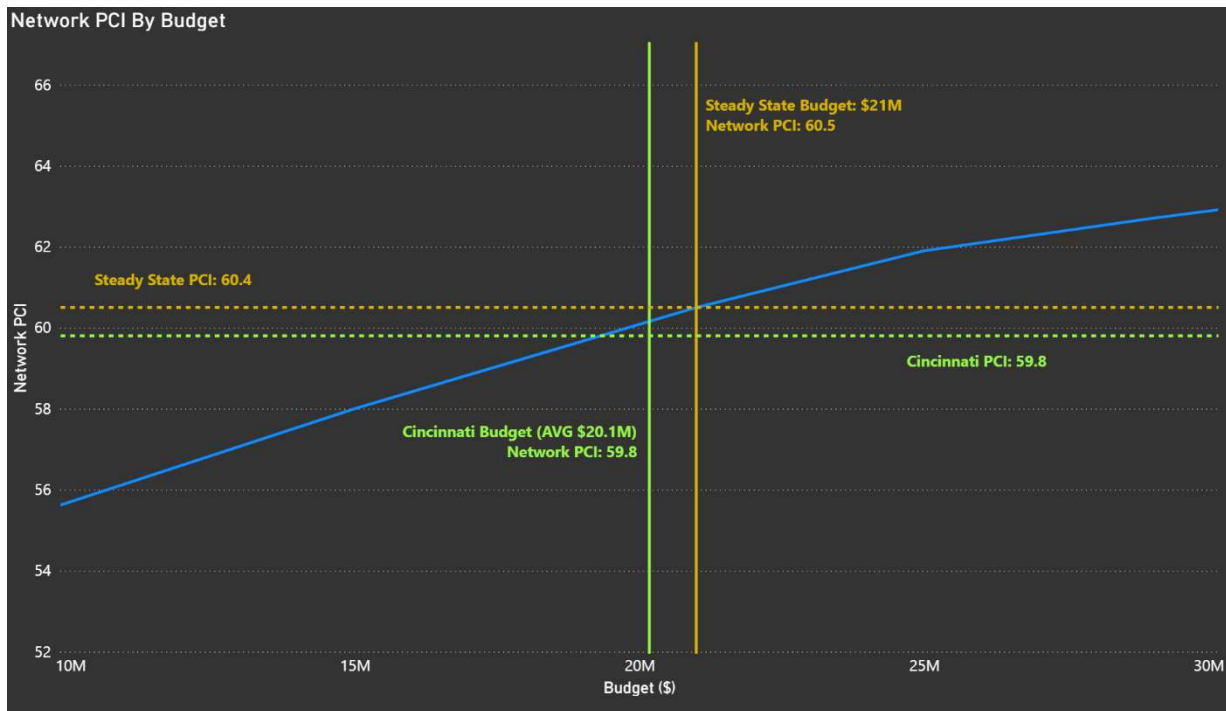
Figure 9.3: City of Cincinnati, OH- Predicted 5-Year Pavement Condition Index Outlook

The network PCI in 2025 was 60.3. With the City’s current budget of ~\$21M annually, the network’s condition will decrease to a PCI of 59.9. Figure 9.3 indicates that a **optimized** budget of approximately \$21,000,000 per year is needed to maintain a network PCI of 60.3 and maintain a consistent level of service to the community. It is important to note that the forced selected of planned work and only selecting certain treatments will have an impact on the ending results. Figure 9.3 can be used to answer and predict the network PCI at any funding level between \$10M per year and \$30M per year. Figure 9.3 was used to predict the PCI at the following budgets in Table 9.5.

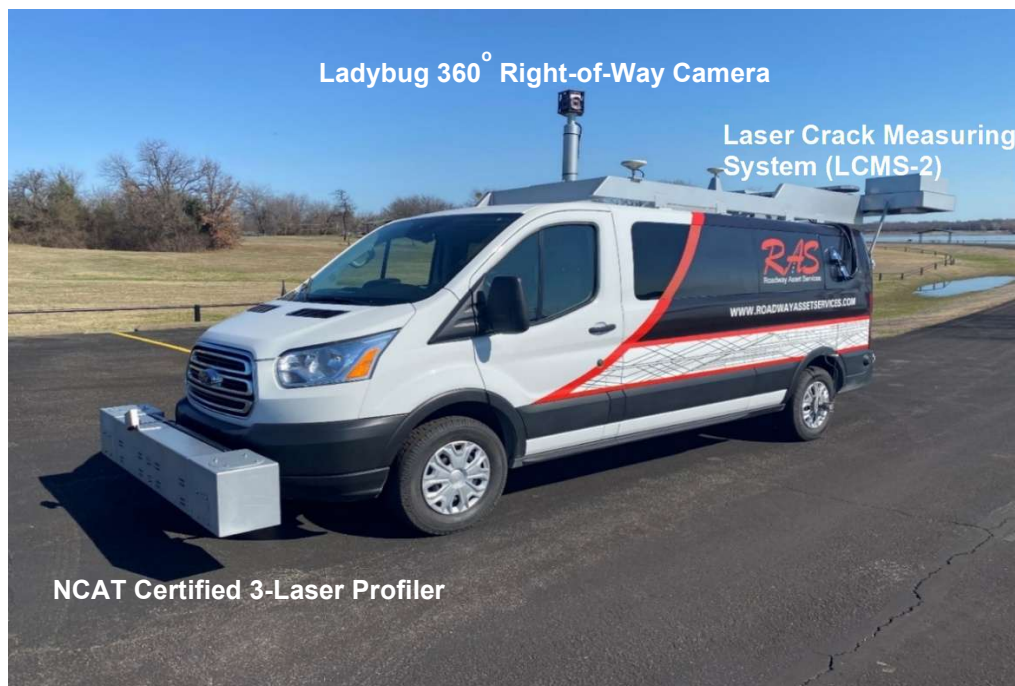
Figure 12.1: RAS RAC Vehicle

- An inertial profiler with line lasers (Used to capture International Roughness Index (IRI) measurements).

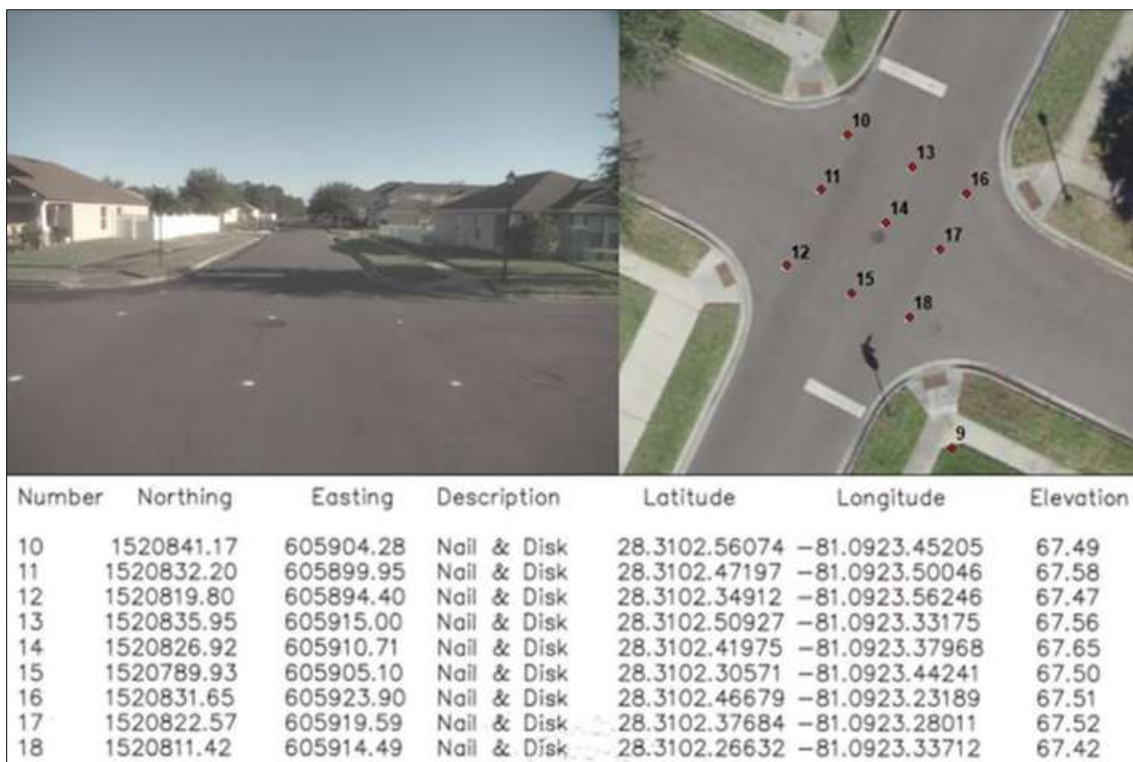
Figure 12.2: 9-Point Calibration Site Example

RAS RAC image collection includes a daily check of the on-board systems. This vehicle component check includes a calibration site survey of a nine-point grid in state plane coordinates (Figure 12.2). Each morning and afternoon, before and after a day’s image collection, the RAC vehicle drives over the surveyed location. The RAC technician then extracts each point’s location to verify the location of the point extracted was within approximately three feet of the surveyed points. RAS’ QA/QC manual includes further details regarding RAC quality control procedures.

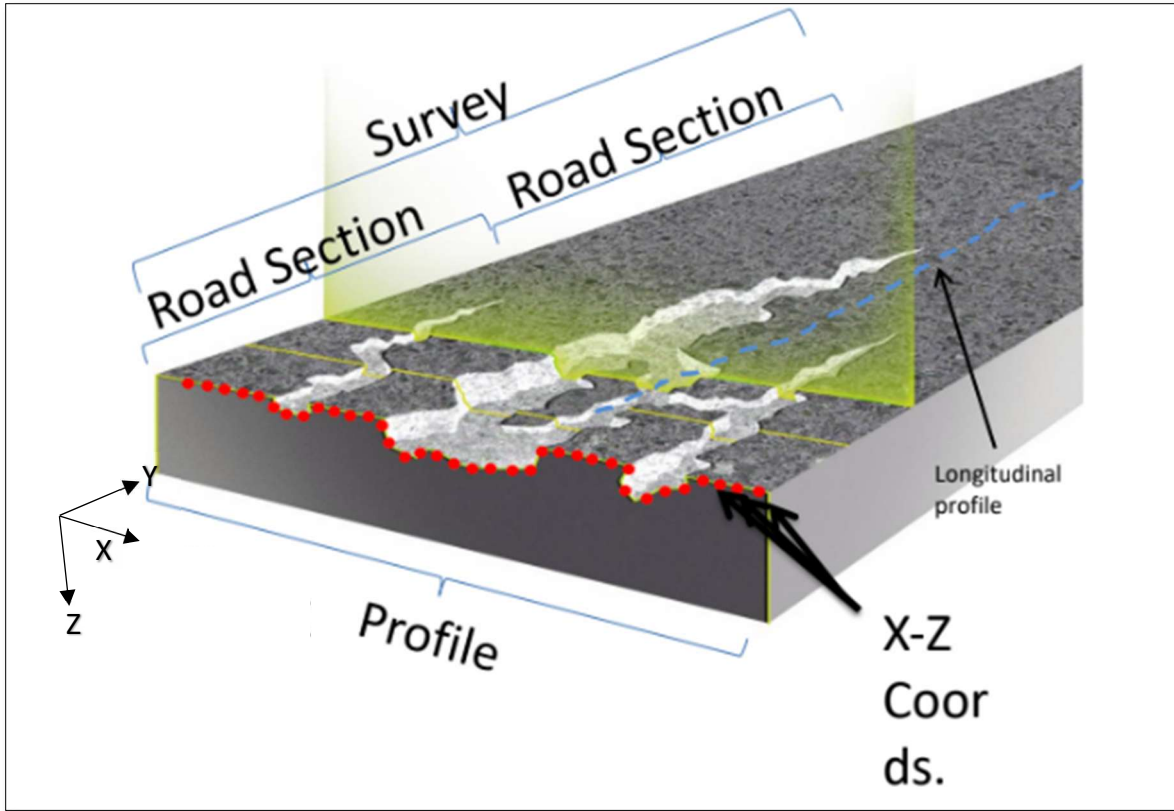
Figure 12.3: LCMS Data Definition

A road section is a set of consecutive profiles that are merged and saved in a common file. A road section can be seen as a set of 3D coordinates (X, Y ,Z), where X is the coordinate along the transversal axis of the road, Y along the longitudinal axis, and Z is the depth axis, as displayed in Figure 12.3. The road section length is configurable and is set by the user before starting the acquisition. A typical road section length is between 5 to 10 meters.
