2025 RETAINING WALL AND LANDSLIDE REPORT

Department of Transportation and Engineering
Division of Engineering
Structures and Geotechnical Section

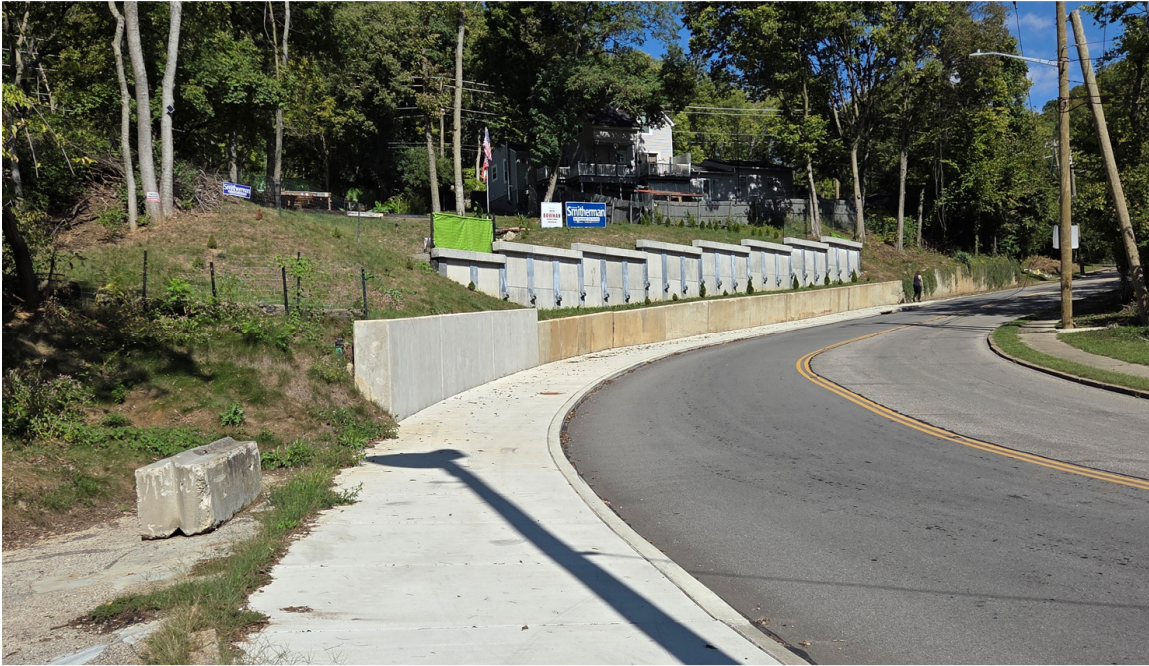
Anderson Ferry, Completed

Hillside movement had caused the retaining wall along the west side of Anderson Ferry Road, between Hillside Avenue and River Road to flex and the wall was being overtopped by soil. The sidewalk had buckled and was closed in February of 2020. The project has stabilized the slope with a tied-back soldier pile retaining wall constructed behind the existing wall. The wall was also extended 45 feet south from the existing wall to allow for the walk to be extended, closing a long-standing gap. The new walls allow stormwater infrastructure to properly collect water behind the wall to allow the sidewalk to be repaired and extended to River Road.

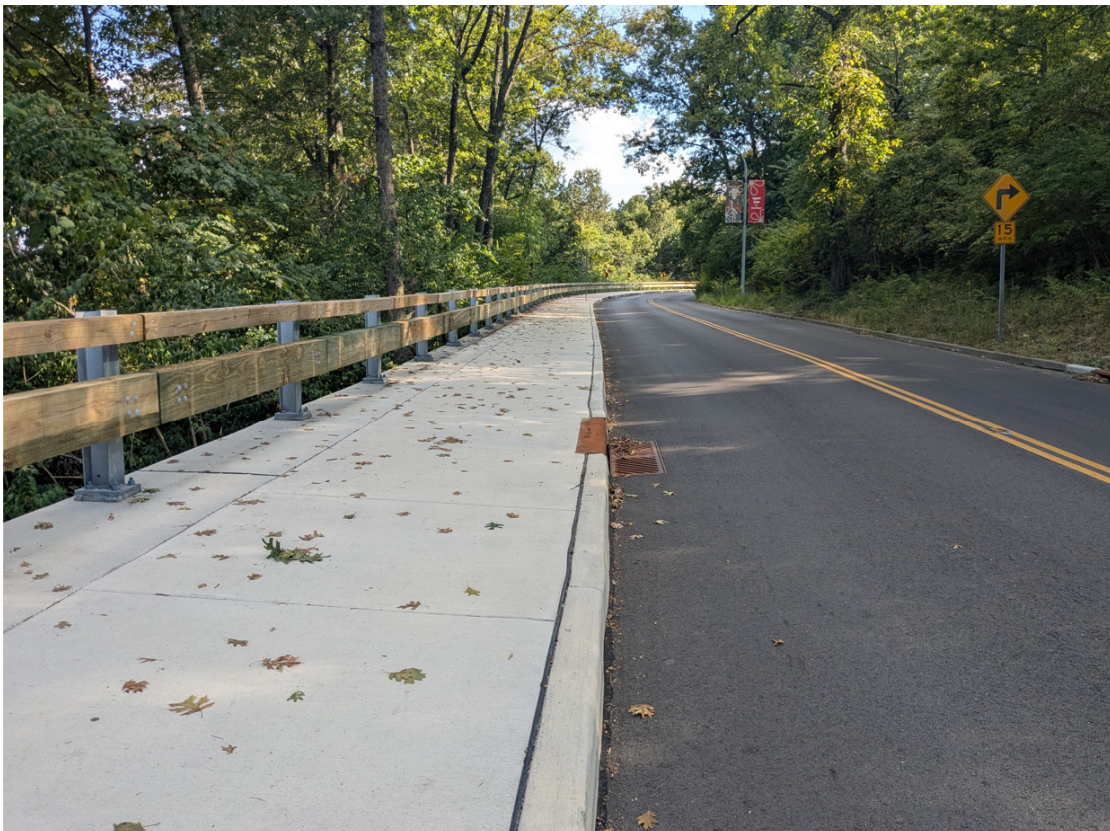
Art Museum Drive, Completed

Hillside movement impacted Art Museum Drive for a distance of approximately 662 feet from its intersection with Eden Park Drive. The retaining wall constructed in the 1930's was founded within the overburden soil and was failing, causing separation of the sidewalk from the curb, deterioration of the sidewalk, separation of the curb from the roadway and tension cracks within the pavement.

The stabilization project involved the installation of a drilled pier retaining wall along the downhill side of the existing retaining wall. Thirty-inch diameter piers were installed at eight (8) feet on center. Precast concrete panels and a wall cap were installed between and on top of the piers. The sidewalk was widened and a new vehicle barrier and pedestrian rail were installed on the wall. The existing cable post guardrail on the south side of Eden Park Drive was also replaced with steel-backed timber rail as part of this project.

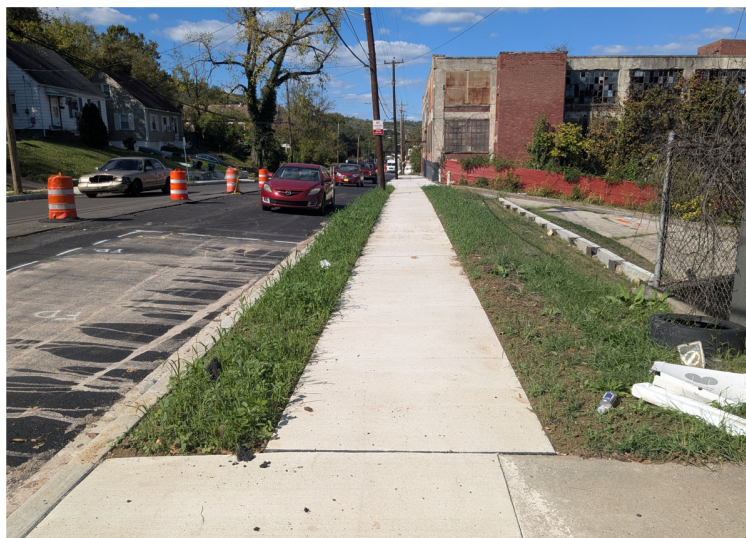
Beekman Street, Completed (Roadway Work Ongoing)

A private retaining wall collapse on the property at 3090 Beekman Street caused a landslide that extended up to the roadway, resulting in the destruction of the sidewalk and the realignment of curb. Pavement was being distressed and there was fear of distress to adjacent utilities. The Department of Community and Economic Development (DCED) had taken control of the property.

DOTe designed a soldier pile wall comprised of 12 piers with steel piles and pre-cast concrete lagging panels. DOTe was awarded OPWC SCIP funding for a much larger street improvement/pedestrian safety project that included this wall as it was needed to repair the sidewalk, curb and pavement in this area. The overall project funding sources, in conjunction with the SCIP grant, were able to cover the cost for the wall/landslide repair. The Wall Stabilization and Landslide Correction Program funded the investigation and in-house design (\$17,714).

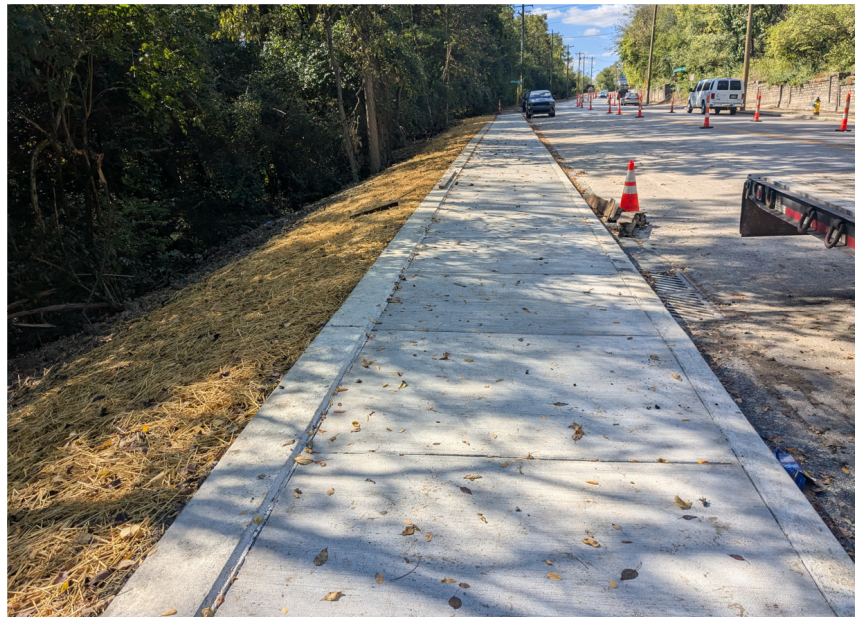
Harrison Avenue, Wall Complete, Roadway Work Ongoing

Private properties that were filled for apartment developments in the early to mid-1900's created an instability along the south side of Harrison Avenue, east of Everglade Place. The apartments were razed in the 1960's due to landslide damage. The landslides span east and west from a single remaining apartment complex at 1765 Harrison Avenue. Slope movement has resulted in the destruction of the sidewalk and the realignment of curb. Pavement was being distressed and there was fear of distress to adjacent utilities. A safety improvement project was planned in the area, requiring the sidewalk to be repaired and reopened. Two (2) drilled piers and plug walls 195 feet and 176 feet in length were designed in-house and constructed as part of the safety improvement project. The wall allows for reconstruction of the curb and walk.

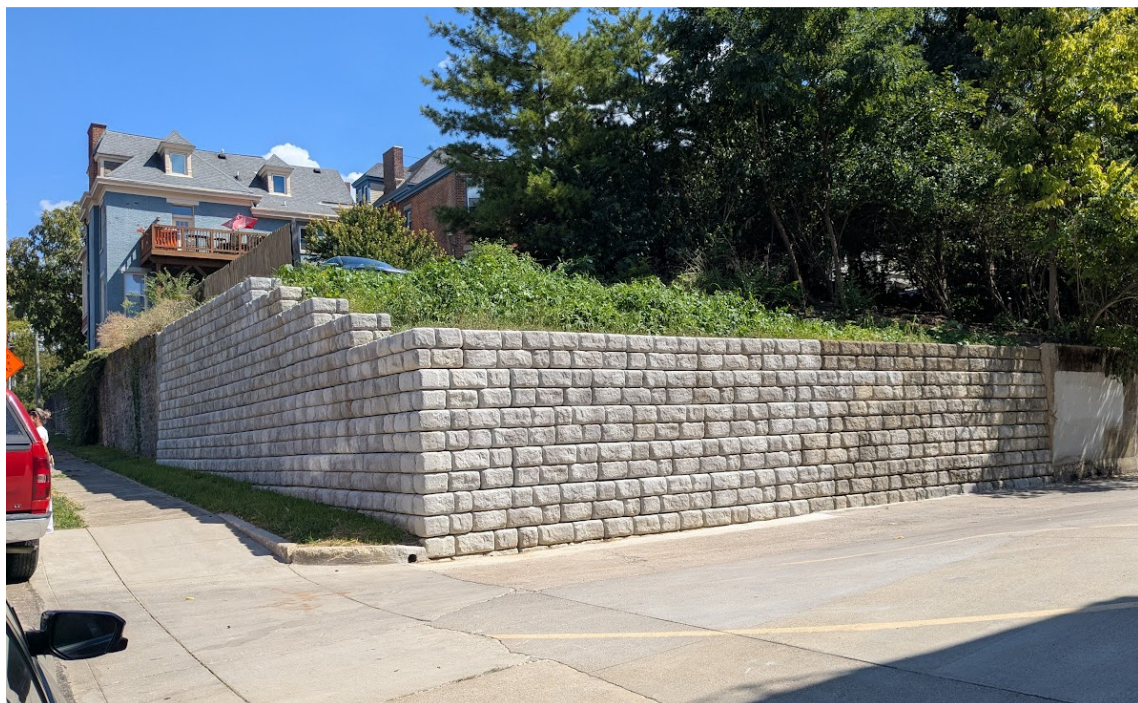
Eucledan Alley Wall Reconstruction - Completed

A 20-foot-long section of cantilevered concrete retaining wall from 1929 at the north end of the alley was at risk of collapse. A similar section to the south of this area was replaced with modular retaining wall units in 2007.

DOTe contracted for the removal and reconstruction of the northern 20 feet of this wall. During construction, it was noted that the 2007 repair was constructed with a batter (lean)

that matched the already leaning section being replaced. As a result, the project was expanded to include restacking of the wall blocks placed in 2007 to better align with the new project and future work that will be needed going further south. This future work is in the 6-year program plan.

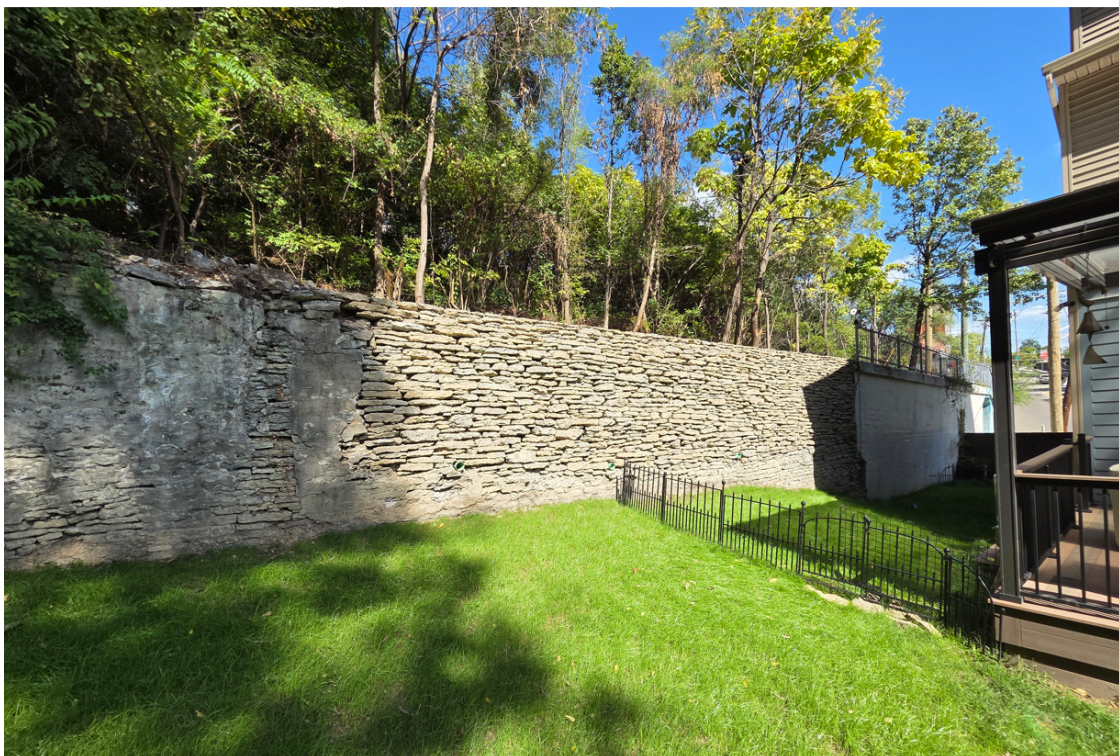
Sycamore Street Wall Reconstruction - Completed

A 40-foot long section of a stone gravity wall located along the north side-yard of the property at 1809 Sycamore Street and presumed to date from the late 1800's/early 1900's was at risk of collapse. The risk of failure could have impacted the adjacent house.

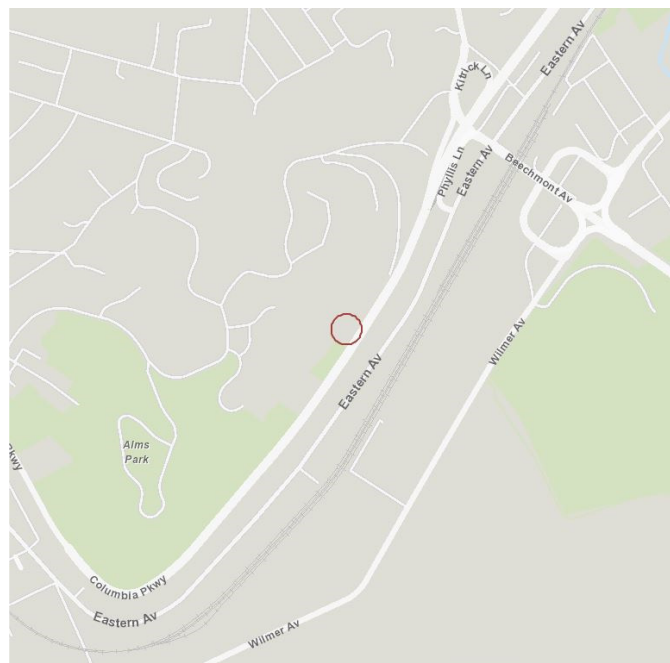
Columbia Parkway Landslide, South of Beechmont, Area Map

Public Services trimmed the vegetation along Columbia Parkway in the summer of 2020. The removal of the vegetation exposed the toe of a landslide on the hillside above the retaining wall between Beechmont Avenue and the curve in the parkway below Alms Park. Comparison of photographs of the area suggests that the slide occurred sometime after June of 2018.

A drone flight that included LIDAR to produce a topographic survey of the landslide and surrounding area was done in the spring of 2022. Landslide features were surveyed in early spring of 2023 and a test pit investigation was coordinated in spring of 2024. Although the slide mass is relatively dormant, corrective measures are necessary to remove the threat of rapid movement onto the pavement. Removal of the toe cannot take place until the slide mass is stabilized.
